F'IS Newsletter

July 2007

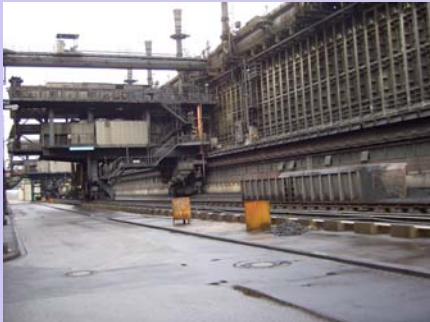
F'IS Services: Damage Detection at Metallurgical Plant

A metallurgical plant in Germany had the bearings in one of the coal mills at their coking plant checked by F'IS for signs of damage. Both the locating bearing and the floating bearing were found to have an emerging damage to the outer ring. As the damaged bearings could have caused damage to the machine itself, resulting in unplanned downtime if not replaced in time, our experts recommended to replace the bearings during the next scheduled shutdown. This enables the operator to schedule maintenance activities efficiently, ensures the availability of the coal mill and reduces the amount of costly downtime to a minimum.

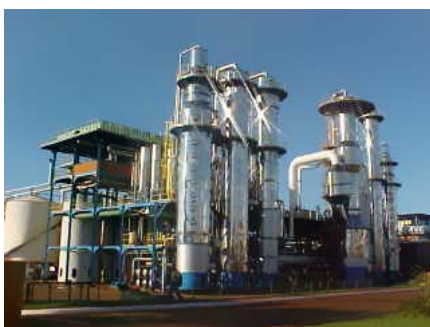
F'IS Services: Process Optimisation at Sugar Factory

The "Vale do Paranaíba" sugar factory in Brazil is one of the most state-of-the-art in the world; still, one drive motor failed shortly after initial startup, causing costly production losses. The operator consulted the F'IS experts, who found that the motor was lubricated with an insufficient amount of lubricant, which also turned out to be unsuitable. Following the experts' recommendation, an 8-channel FAG DTECT X1 system and an automatic lubricator Motion Guard Champion with Arcanol Temp 90 grease were installed. This introduction of condition-based maintenance has already helped to avoid another machine failure. This saves the customer around \$ 480,000.

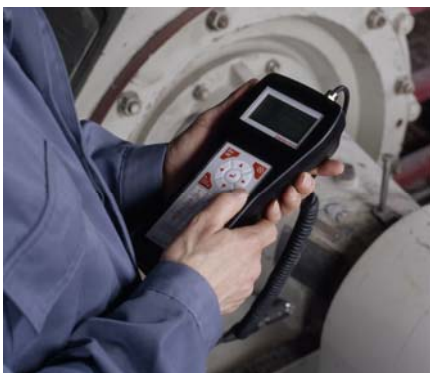
F'IS Services: Gear Box Damage Detected in Good Time

A leading industrial group, which is located in Switzerland, has its production plants serviced by F'IS. When the control unit of a sand mixing drum did not work properly, the F'IS experts were asked to carry out a trouble shooting procedure with an FAG Detector III to determine the cause. They detected a damage pattern in the vibration frequency for the outer ring of one of the input shaft bearings in the gear box of the sand mixing drum. The damaged component was then replaced within a scheduled maintenance window. A reference measurement conducted afterwards yielded normal readings. The control unit is now working perfectly again, production losses have been prevented, and the operator has the reassuring certainty that the machine is now in excellent condition.
